NASA CR-121000

BASIC FAILURE MECHANISMS IN ADVANCED COMPOSITES

GENERAL ELECTRIC COMPANY
SPACE SCIENCES LABORATORY

16. Abstract The purpose of this effort was to identify failure mechanisms in carbon-epoxy composites as a basis for more reliable prediction of the performance of these materials. The approach involved both the study of local fracture events in model specimens containing small groups of filaments and fractographic examination of high fiber content engineering composites. A good deal of emphasis has been placed on the correlation of model specimen observations with gross fracture modes. The effects of fiber surface treatment, resin modification and fiber content were studied and acoustic emission methods were applied. Some effort was devoted to analysis of the failure process in composite/metal specimens.

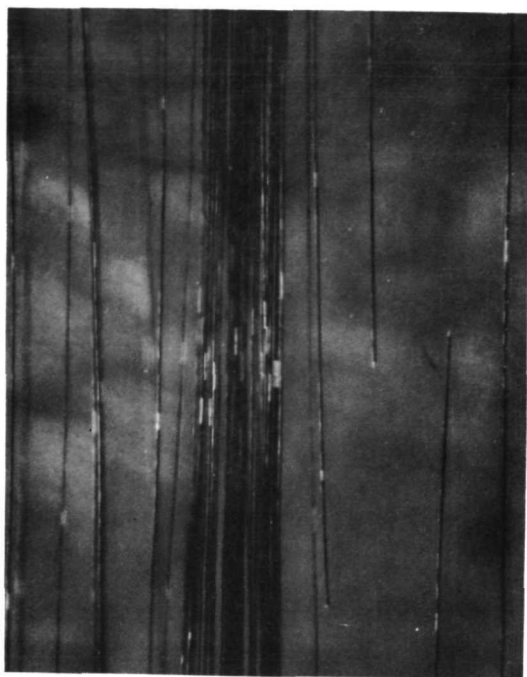
Consider first the local fracture mechanisms shown in Figure 15 for small groups of fibers encapsulated in the modified resin formulation and tested in tension. The untreated fibers in the upper photos of Figure 15 failed with no evidence of matrix cracks normal to the fiber but instead, localized debonding extending a few fiber diameters on either side of the fiber fracture site. This behavior is in sharp contrast to that of the surface treated (HTS) fiber specimen shown in the lower photos where there is definite evidence of matrix cleavage normal to the fibers and little evidence of debonding. Clearly, the fiber surface treatment has strengthened the interfacial bond and changed the local energy dissipation from an interfacial separation to a matrix fracture mode. This behavior is not unexpected since the surface treatment was developed to enhance the bond strength and thus improve both interlaminar shear and transverse composite strength.

Figure 15: Comparison of Fracture Mechanisms for Treated and Untreated HT Fibers

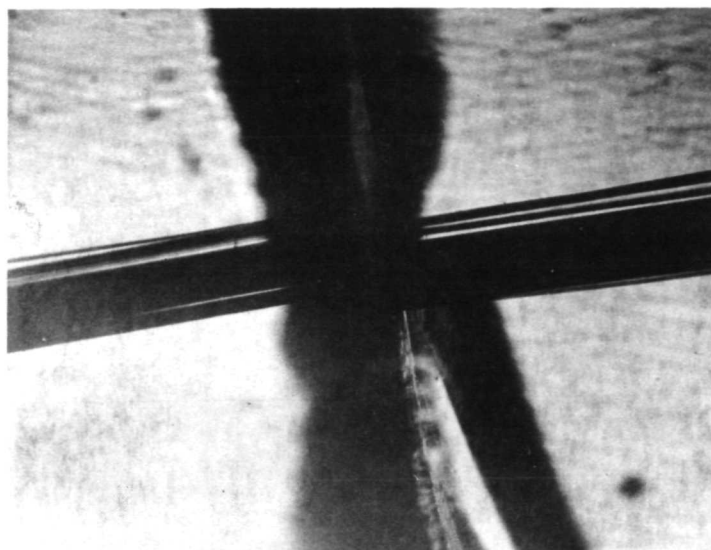
Typical Fracture Profile for Both Treated and Untreated
HT Fibers

Figure 19. Comparison of Fracture Surfaces for HT Fibers
in ERLB 4617 Resin

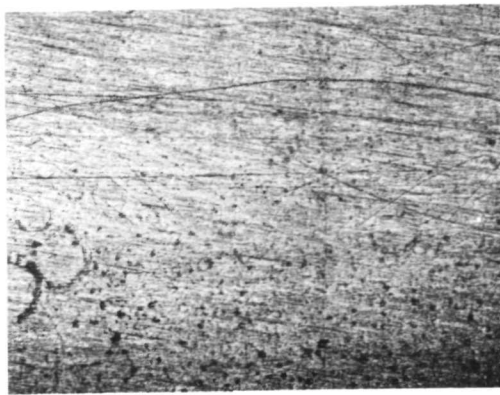
ORIGINAL SURFACE
(12X)

Figure 31. Photographs of Specimen HTUR-4 Showing Longitudinal Splitting Prior to Failure

The total accumulation of these failures range from about a half dozen to about 30, depending on the amplifier attenuation level being used and the propensity of the specimen to splitting. For specimens which fail primarily by cleavage, for example, fewer of these events are noted. However, near the point of final failure these large scale events occur with greater frequency. Based on such observations, the following failure process has been constructed for tensile fracture in a uniaxial carbon epoxy composite. Starting at about 50% of the failure load, fibers begin to fail and the rate increases with increasing load. Near groups of failed fibers, the matrix transmits the load between groups of fibers by shear. At intervals, the matrix shear stress is large enough to cause a local matrix crack, which can then propagate longitudinally some distance along the specimen length. This process continues until the longitudinal cracks link up by transverse cracks, and the specimen fails. The amount of such splitting is a strong function of the interfacial bond strength, as discussed in Section 3.1. After failure, the post-fracture shock wave can cause extensive fragmentation if sufficient energy is available and longitudinal splits are present prior to fracture.
